MINNESOTA ARCHITECTURE-HISTORY INVENTORY FORM

Property Location			
Property Name:	Baril's Paint	Inventory No.	ME-LTC-0160
Address:	25 West Second Street	County:	Meeker
City/Twp:	Litchfield	PIN	27-0796000
T-R-S Quarter:	T119N R31W Sec. 11 SW ¼	Block:	64
USGS Quad	Litchfield North, Minnesota	Lot:	Partial D, 1, 2, 3, 4

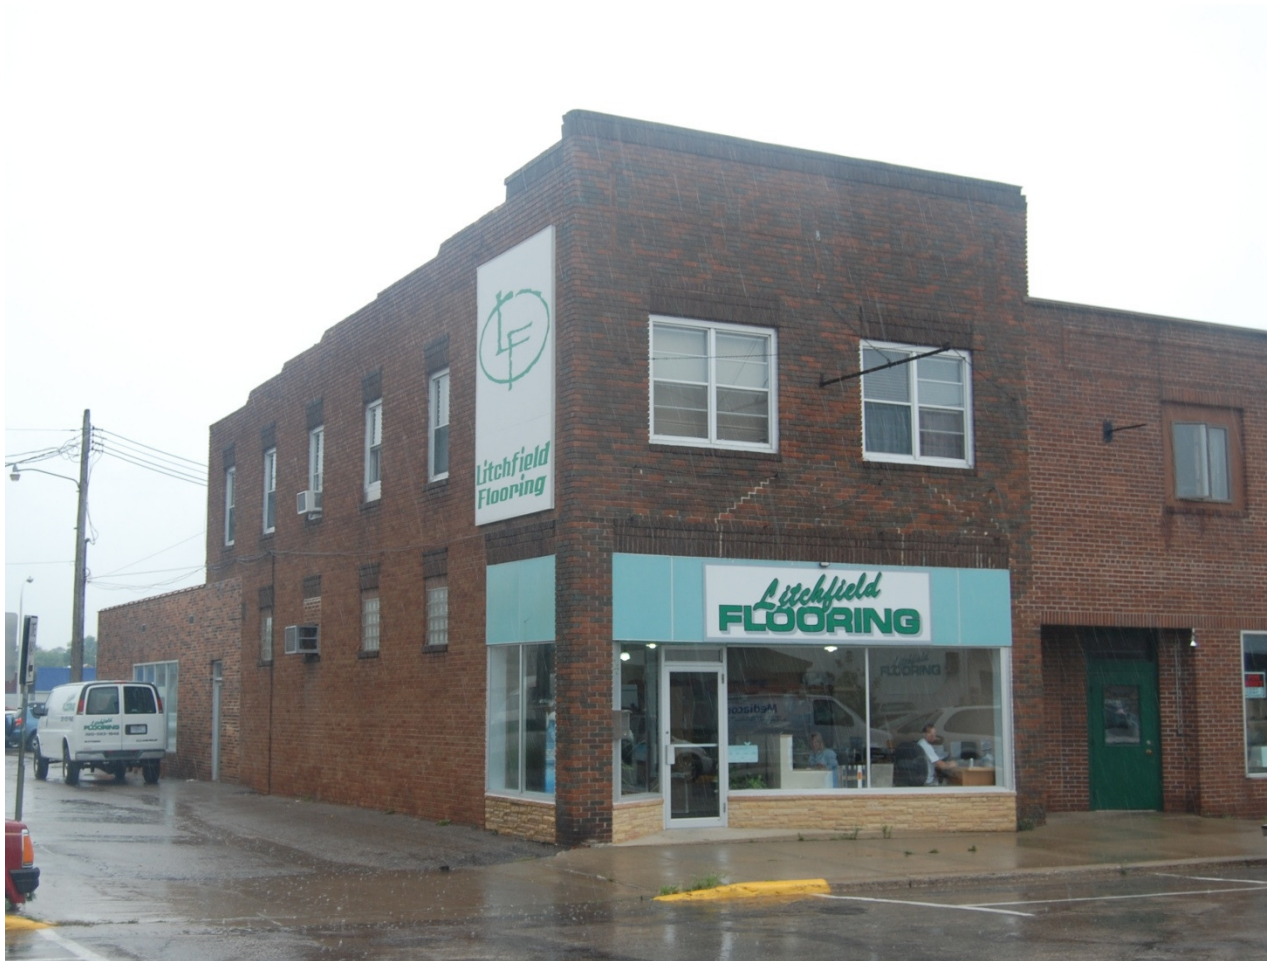
Facing SW

This two-story Commercial Style building is located at the western edge of the historic district. It is faced with medium-brown textured brick. The second story has rectangular window openings with 1/1 sash. On the eastern wall some of the window units have been replaced and resized within the openings. The storefront has been altered with limestone and glazed metal panels and there is a one-story rear brick and concrete block addition.
